Fog Horn used at Low Head lighthouse, Tasmania

Lyndon O'Grady

Australian Maritime Safety Authority

The purpose of this paper is to describe the use and preservation of the fog plant assembly used at Low Head

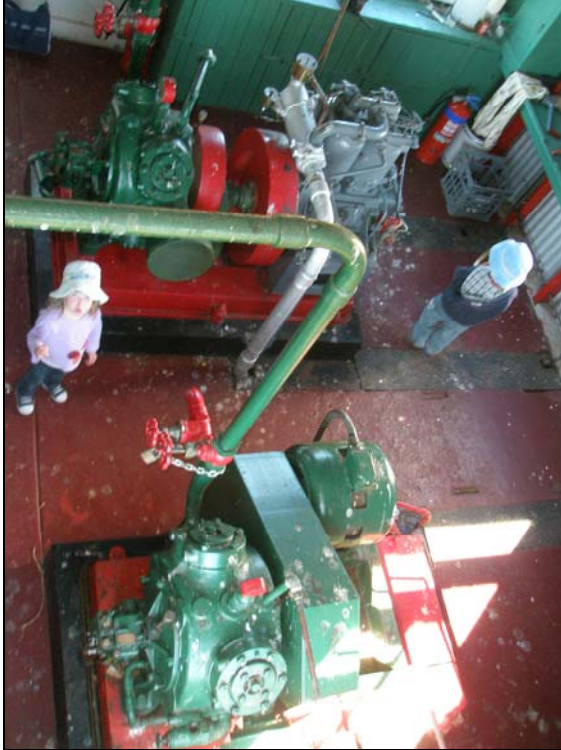
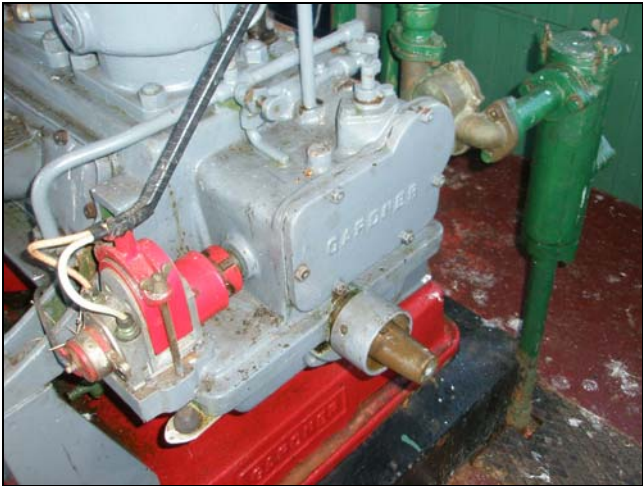
The engine was stripped with the interior found to be in near perfect condition. Further research indicated that this type of engine was good for 500 000 hours before major overhaul, log books for the engine showed only 1200 hours use.

The engine was nearly new.

<p>Top engine is the refurbished Gardner The bottom (spare unit) has the electric motor in place, both compressors are Reavell</p>	<p>Gardner engine</p>

The valves were reground, oil and filters changed and new fuel and water cooling tanks fabricated.

The engine is now fully operational and operates most Sunday afternoons for visitors to the site.

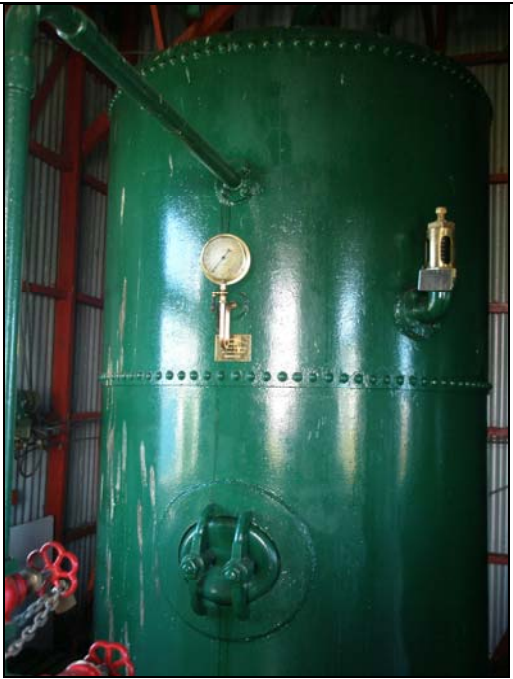
On closer inspection it was found that a leak in the fog horn room roof had resulted in water causing surface rusting to the large rivets of one of the air receivers.

<p>Timing air motor showing two cam wheels on right hand side</p>	<p>Air receiver No.1</p>

Eventually an engineer was found who recommended minor repairs could be made to the receiver that would satisfy the pressure vessel inspecting authorities.

A specialist welder was engaged and the three offending rivets were replaced with high tensile bolts and the work approved by an inspecting engineer.
