Fog Horn used at Low Head lighthouse, Tasmania

Lyndon O'Grady

Australian Maritime Safety Authority

The purpose of this paper is to describe the use and preservation of the fog plant assembly used at Low Head

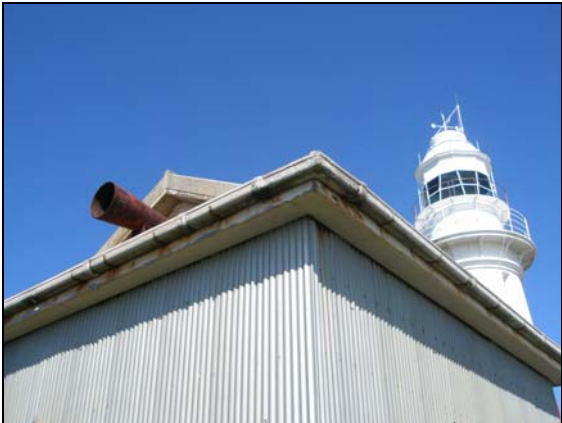
A photograph of an external trumpet (bell) mounted on a white corrugated metal roof. In the background, a white lighthouse is visible against a clear blue sky.
<p>Sounding valve and driving valve (upper) External trumpet is attached to upper drive valve</p>	<p>External trumpet with lighthouse in background</p>

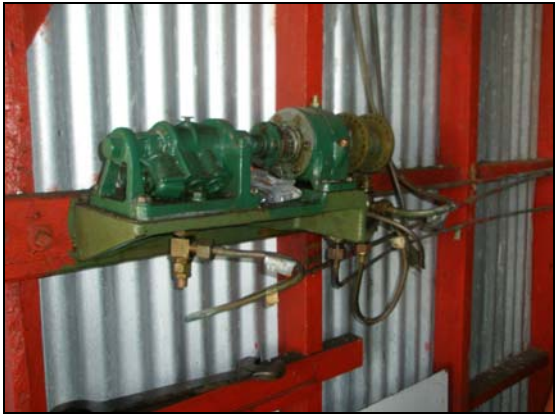
On closer inspection it was found that a leak in the fog horn room roof had resulted in water causing surface rusting to the large rivets of one of the air receivers.

<p>Timing air motor showing two cam wheels on right hand side</p>	<p>Air receiver No.1</p>

A specialist welder was engaged and the three offending rivets were replaced with high tensile bolts and the work approved by an inspecting engineer.
